The Story of the Chocorua Dam and Park

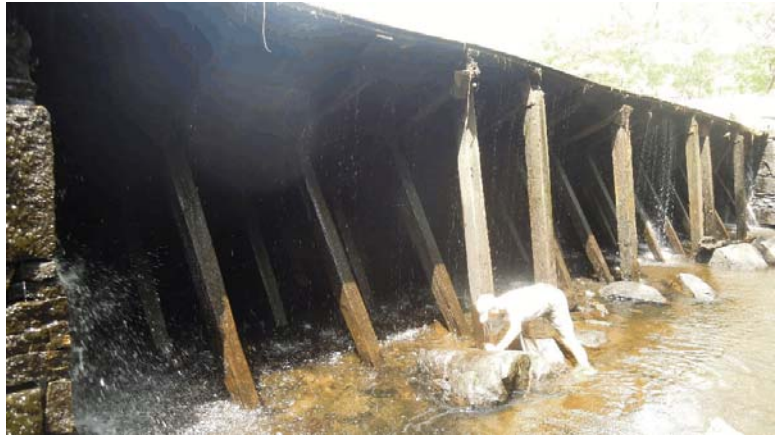
To preserve the structural integrity of the Dam, the Park owner and others on the Dam Committee developed a plan to replace the missing upright timbers (struts) that support the lip of the dam. On June 10, 2015, the penstock was opened half way, lowering the water level in the pond approximately six inches, which allowed inspection and measurement of the wooden structure that is normally hidden behind the waterfall. With this information, and the assistance of a professional engineer, detailed repair plans were formulated. Since the NH Dam Bureau agreed that the work could proceed as a “repair”, the considerable time and cost associated with any “reconstruction” work was avoided. And because the water level in the pond would only be lowered about four feet, and there would be no digging or machinery in the river, no further permits were necessary, allowing the design and planning to proceed rapidly so the work could be performed while the river was at its lowest in mid-summer.

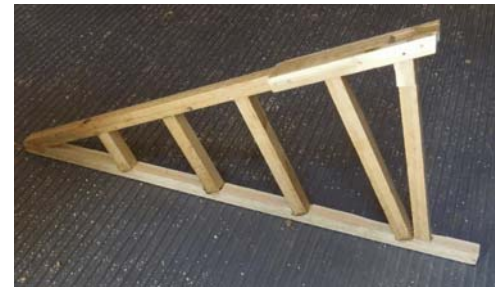
Actual repairs occurred during the week of July 28th, 2015, with the replacement of all sixteen of the primary struts that support the lip of the dam. Local lumber mills produced the new 8x8 inch struts from locally-harvested Eastern Hemlock. The actual timber work was conducted by experienced timber framers, cutting a tenon at the base of each new strut that fit into the existing slots (mortises) in the existing sills. With the assistance of Dam Committee members and other volunteers, the timbers were raised into place and held between two hemlock “repair plates”, which in turn were fastened to the existing structure using substantial 3/4 inch bolts. Five of the secondary struts were also replaced, and a new “wear plate” was installed along the lip, helping to reinforce and straighten the edge of the dam and produce a more uniform waterfall. While the pond was lowered, a number of holes were plugged in the upstream face of the dam, eliminating most of the water that previously leaked through the stonework. This intensive effort was completed in just seven days, allowing the pond to be quickly refilled for the continued enjoyment of residents and visitors alike.

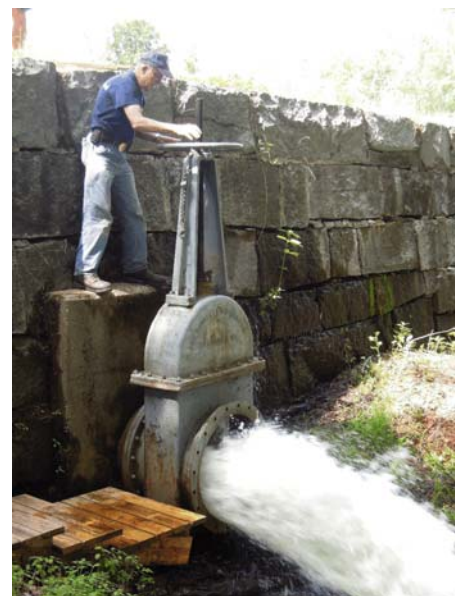
Although the 2015 repairs were originally seen as a temporary measure, the overall condition of the structure turned out to be very good, so a near-term replacement of the dam is no longer seen as a necessity. However, there are still a number of other repairs to be performed, including replacement of the 4x4 wooden gate and repair of the trash rack and penstock valve. A survey of hydroelectric potential is also underway, but preliminary results suggest that the payback period would be over 20 years, making a full-scale installation unfeasible. However, a demonstration or educational installation is still being considered.
